Home Inspection Report

3341 Karen ave, Kingman, Arizona 86408

Thursday, August 10, 2017

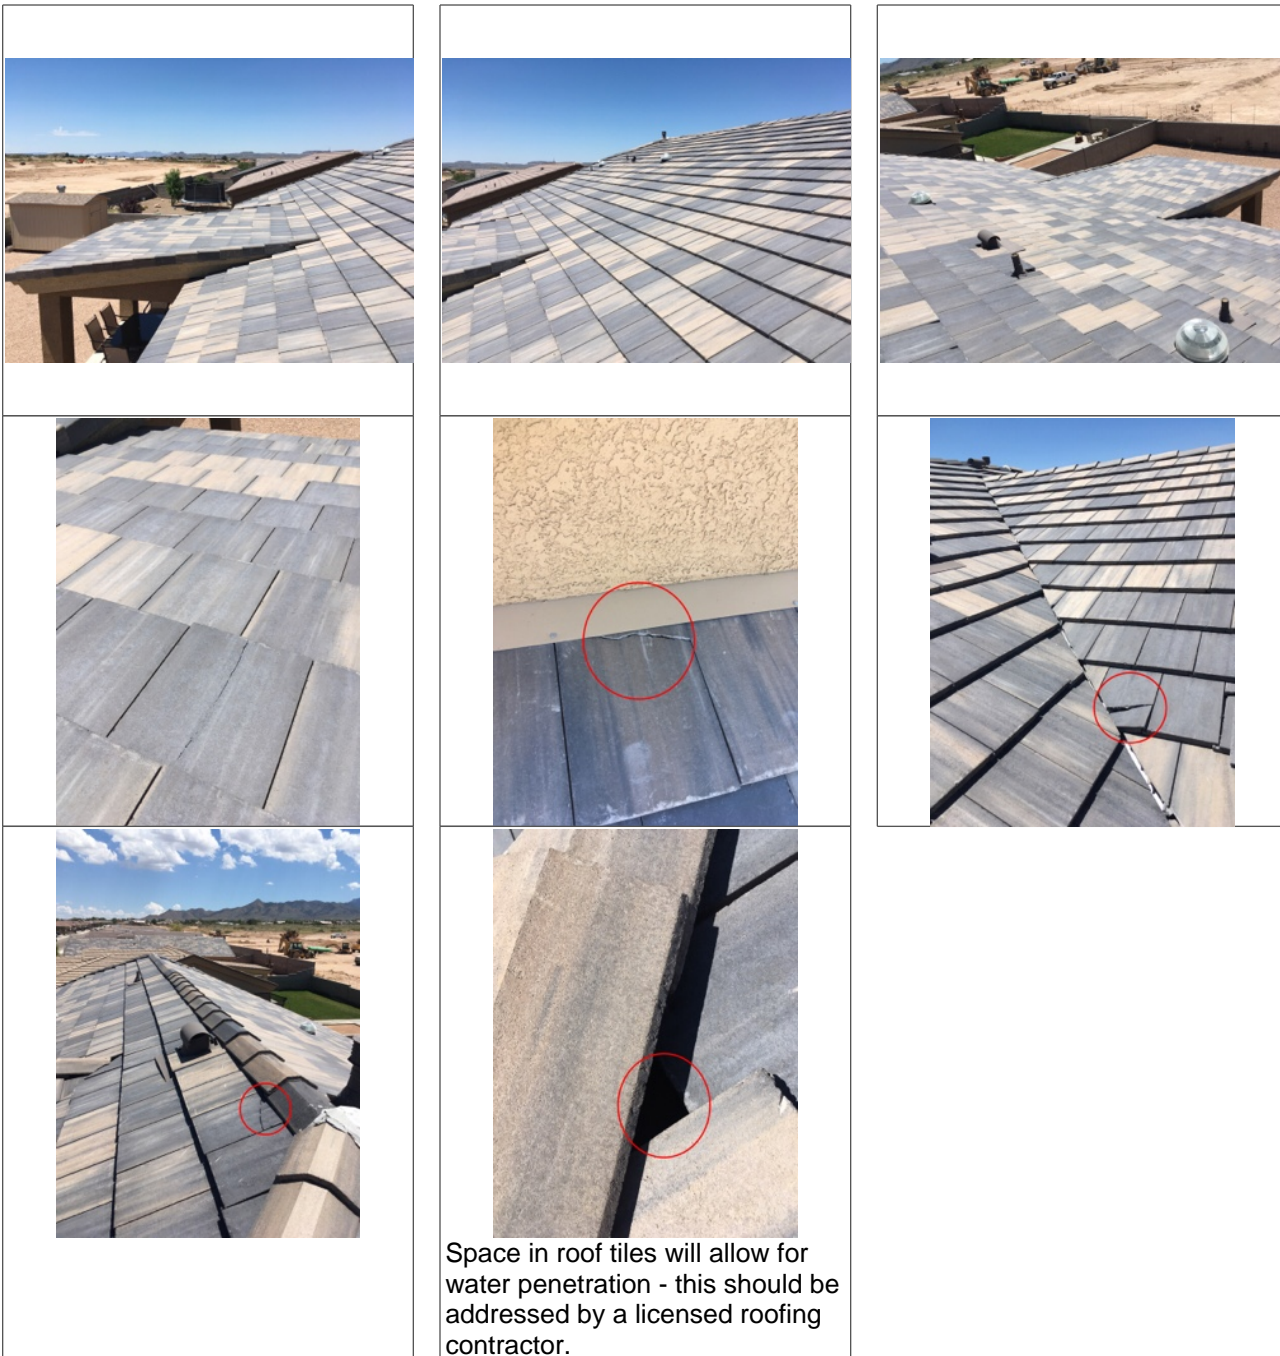
6 cracked tiles found on roof and gap found at the western facing ridge. These are very typical. However, should be addressed by a roofing contractor. See roofing area of report for illustrations.

Space in roof tiles will allow for water penetration - this should be addressed by a licensed roofing contractor.

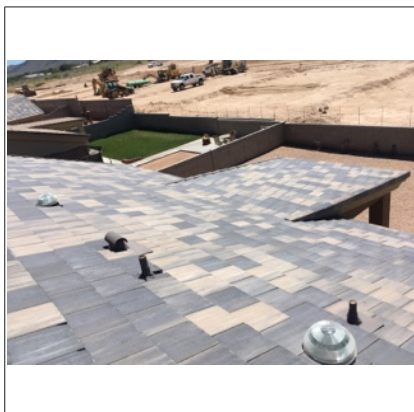
N/A Not Visible
Condition Cracked/Broken Satisfactory Marginal Poor
Comments 3 solar tubes - all appear to be working and in satisfactory condition
Photos

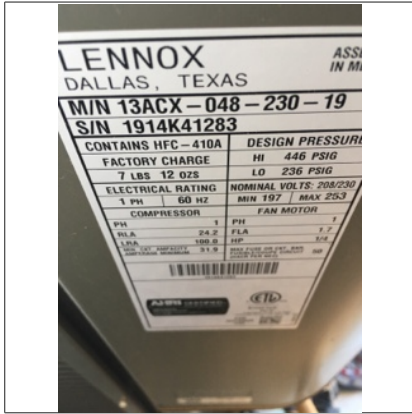
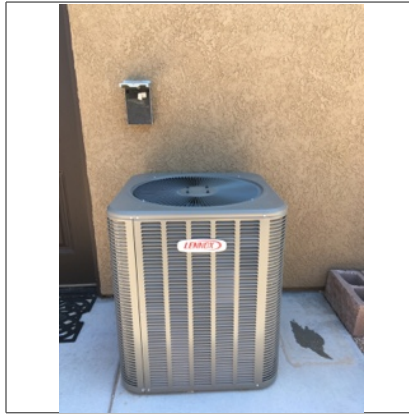
Unit #1 N/A
 Location:
 West side of home
 Brand:
 Lennox
 Model #:
 13ACX-048-230-19
 Serial #: 1914K41283
 Approximate Age:
 3
Condition Satisfactory Marginal Poor Cabinet/housing rusted
Energy source Electric Gas Other: .
Unit type Air cooled Water cooled Geothermal Heat pump
Outside Disconnect Yes No Maximum fuse/breaker rating (amps): 50 Fuses/Breakers installed (amps): 50
 Improperly sized fuses/breakers
Level Yes No Recommend re-level unit
Condenser Fins Damaged Need cleaning Damaged base/pad Damaged Refrigerant Line Satisfactory
Insulation Yes No Replace
Improper Clearance (air flow) Yes No
Comments Air conditioner appeared to be in normal working order.

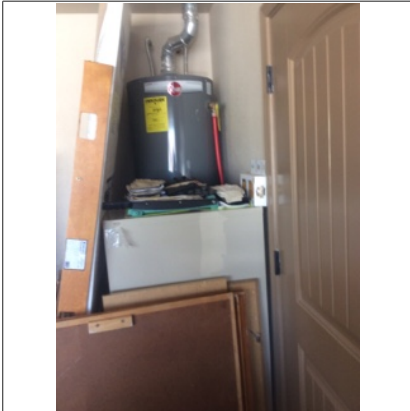
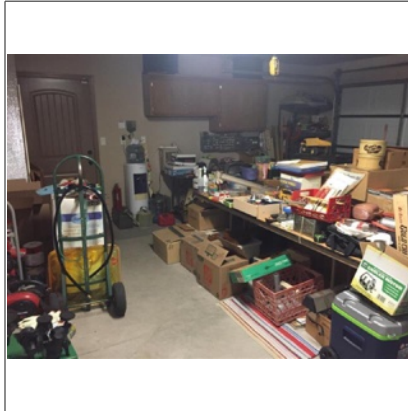
None
 Attached Detached 1-Car 2-Car 3-Car 4-Car Carport
Comments Water heater with storage surrounding- unable to visualize burner or elements.

Garage area of the home was heavily occupied at the time of the inspection and large sections of the area were not able to be properly evaluated. I did not observe any major damage that would appear to require significant actions. You may elect to conduct a formal walk through once it has been vacated.

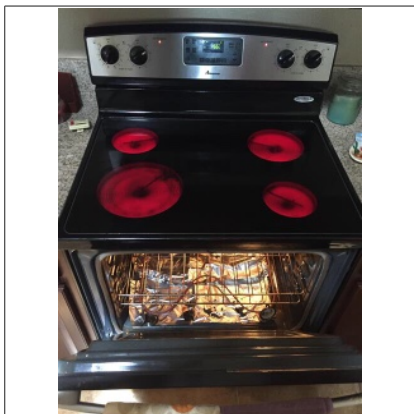
Oven in kitchen does not have anti-tip device. Recommend install per manufacturer's recommendation.

Comments Oven does not have functioning anti-tip device. This is a safety concern especially if there is a chance children will be in the home. I recommend having anti-tip device installed per manufacturer's recommendation.

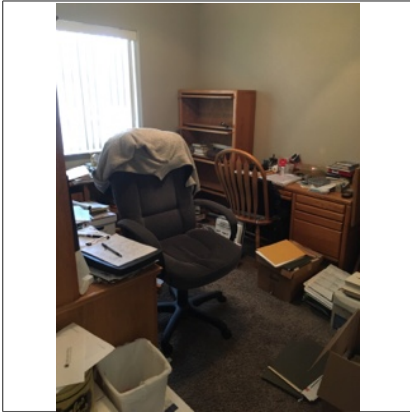
Comments All receptacles could not be checked due to boxes and packed objects through out room.

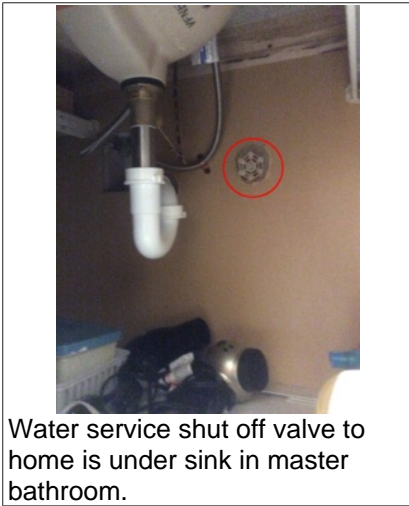
Water service shut off valve to home is under sink in master bathroom.

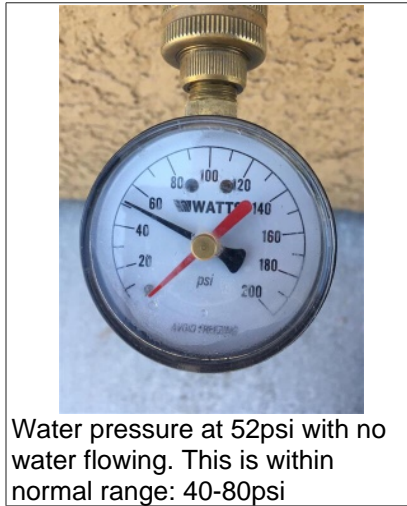
Water pressure at 52psi with no water flowing. This is within normal range: 40-80psi

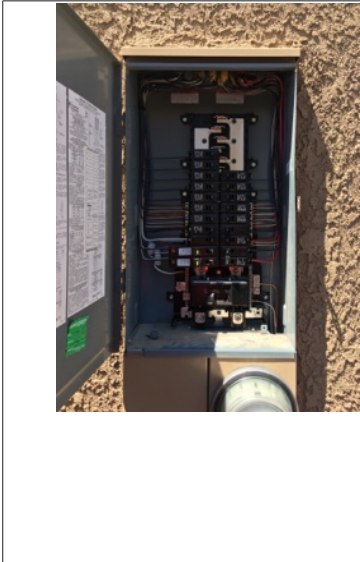
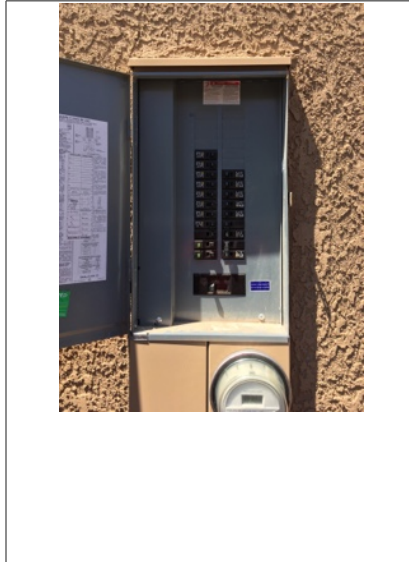
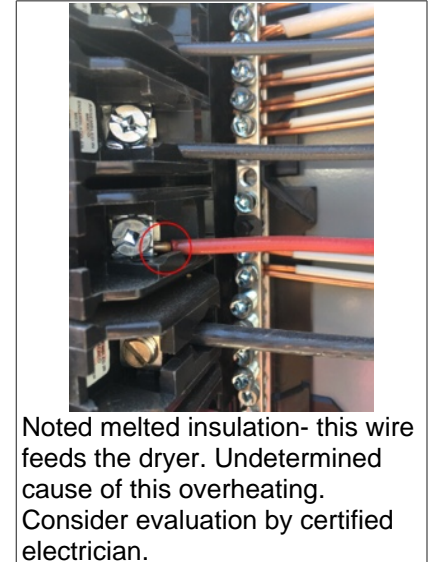
Overheated wire found in main panel. See electrical section of report

Comments Branch wiring to dryer found with evidence of overheating- melted insulation. Recommend evaluation.

Noted melted insulation- this wire feeds the dryer. Undetermined cause of this overheating. Consider evaluation by certified electrician.
