Home Inspection Report

3341 Karen ave, Kingman, Arizona 86408

Thursday, August 10, 2017

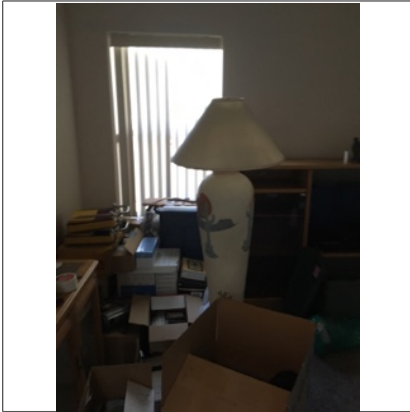
Location East
Type BEDROOM
Walls & Ceiling Satisfactory Marginal Poor Typical cracks Damage
Moisture stains Yes No
 Where:
Floor Satisfactory Marginal Poor Squeaks Slopes Tripping hazard
Ceiling fan None Satisfactory Marginal Poor Recommend repair/replace
Electrical Switches: Yes No Operable Receptacles: Yes No Operable
 Open ground/Reverse polarity: Yes No Safety hazard Cover plates missing
Heating source present Yes No Holes: Doors Walls Ceilings
Bedroom Egress restricted N/A Yes No
Doors None Satisfactory Marginal Poor Cracked glass Broken/Missing hardware
Windows None Satisfactory Marginal Poor Cracked glass Evidence of leaking insulated glass
 Broken/Missing hardware
Comments All receptacles could not be checked due to boxes and packed objects through out room.
Photos

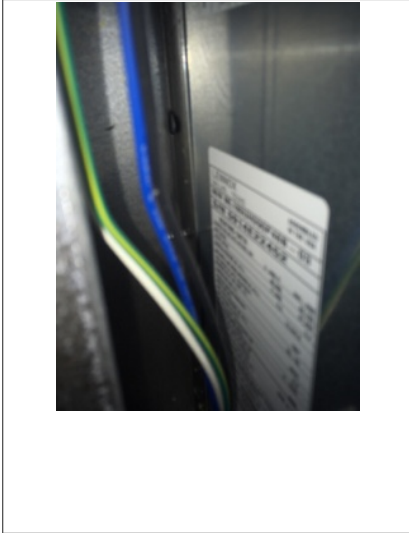
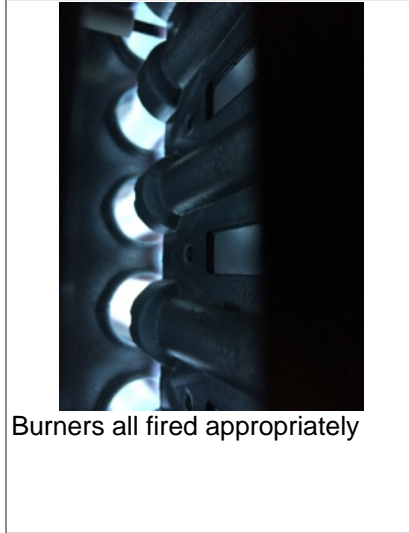
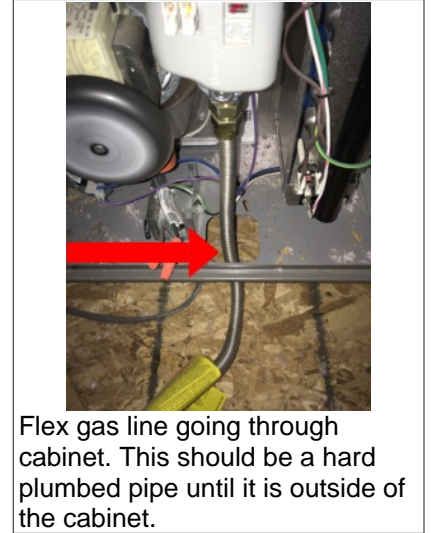
Gas flex line into cabinet of furnace. See heating section of report.
